Conductor Bar in EMS-Systems Program 0811

- 08-S265-2346-002
- 08-S265-2345-002
- 08-P025-0191-001
- 08-P025-0192-001

Contents

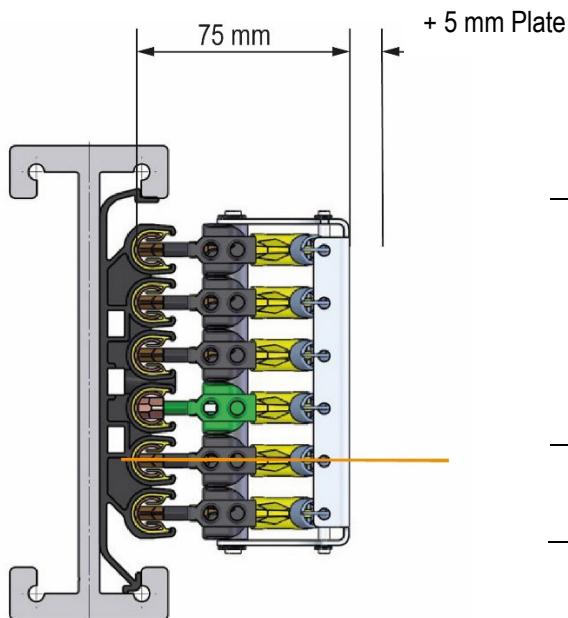
Fig. 4: Replace copper-graphite Collectors with pure graphite Collectors

1. Old copper- graphite collector height (when engaged): 80 mm (due to brush head with 10 mm height).
New pure graphite collector height (when engaged): 75 mm (due to brush head with 5 mm height)
Plate 5 mm must be used
2. Collector adjustment: Exact center line of copper rail and brush head to be kept

BMW stipulates a plate with a cable guide 08-P025-0191-001. This plate must be considered for new installations and rebuilding. It allows the obeying of the correct installation dimensions and a safe cable guide.
For EMS applications which are not used for BMW we also recommend to retrofit the plate according to the distance dimension of 75 mm.

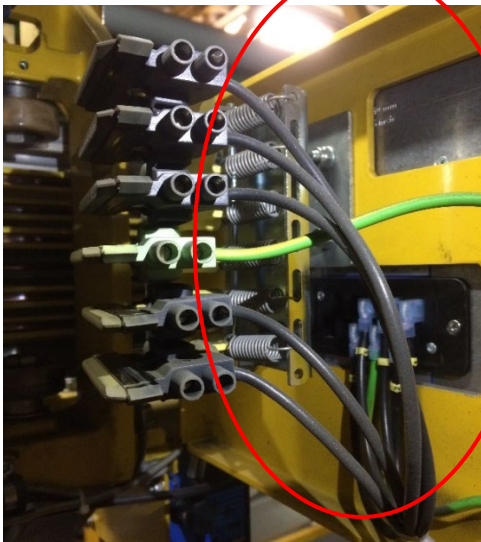
Fig. 5: Cables which are not installed correctly

1. Cables are not installed correctly:
 - No parallel cable guide
 - Cable bundle creates force on collector heads
 - Collector heads are not running parallel to conductor rail

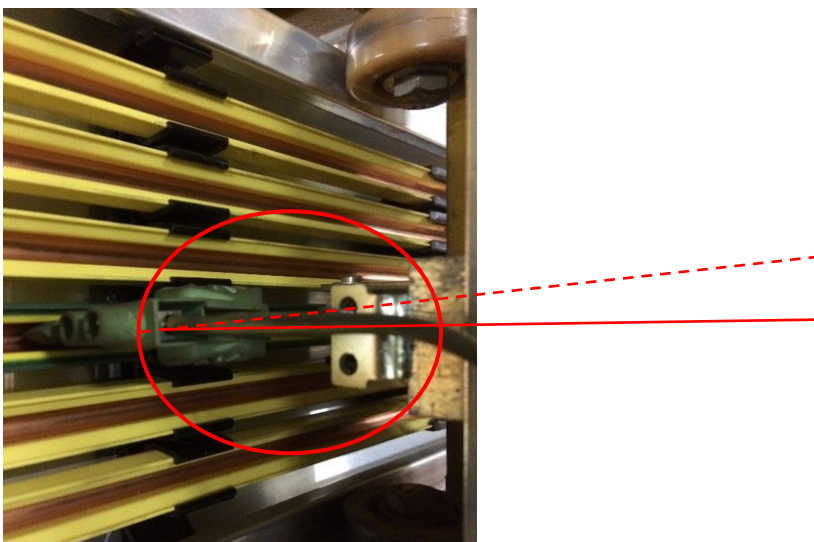
Fig. 6: Collector adjustment

2. Collector adjustment: Brush head not aligned properly (too high!) = Brush head runs permanently in an angle and grinds the plastic isolation of the conductor rail.
