# AXODE Shift Kit<sup>®</sup>

## 1991up AXODE & AX4S

### Reduces/Corrects/Prevents

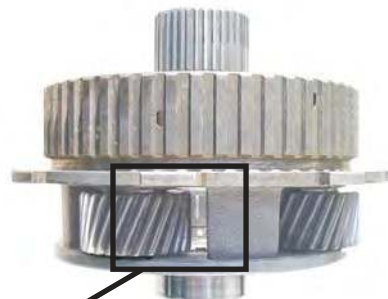
## Front Planetary

**A** Enlarge the two holes just below the needle bearing with the .110 drill furnished.

Insert drill from the side between the pinion gear and housing.

If you can't line up with the holes to drill them, it's **OK** to drill two new .110 holes.

**These upgrades increase lube to front planet about 10 times.**

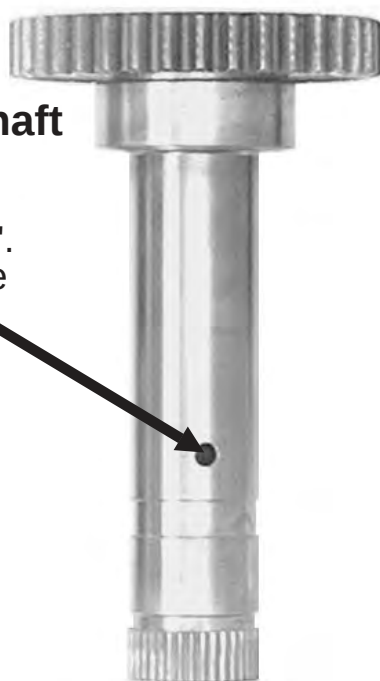
## Sprocket Shaft

**C** Drill both sides  $\frac{1}{4}$ " to  $\frac{3}{8}$ ". De-burr inside with a file.

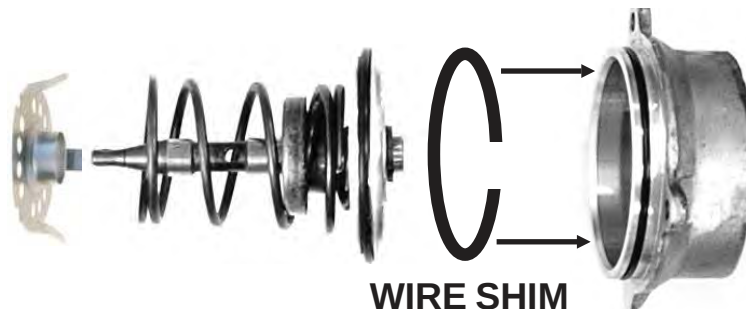
**D 1-2 Servo** (*on side of trans*)  
Install **WIRE SHIM** in cover.

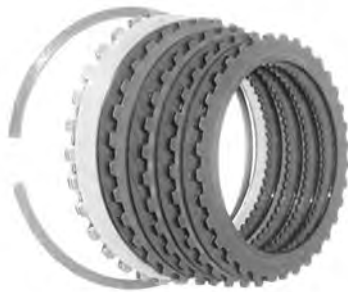
(Green) Hi-Energy 3rd plates with Kolene steels.

1996-01 Vehicles: Came with Hi-Energy (Green) 2nd and 3rd clutches. During light acceleration the ECM commands pressure of 140 to 160 psi. Using brown clutches in these applications will cause rough shift complaint.

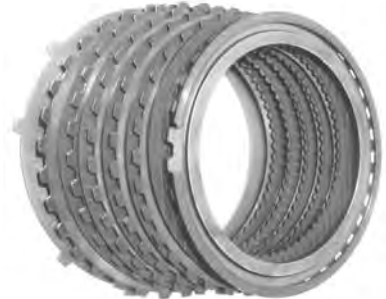
(Green) Hi-Energy 2nd plates with Kolene steels.
